Watch Your Step!

A Study on the Social and
Environmental Impacts of Tanneries in
Uttar Pradesh and Tamil Nadu, India

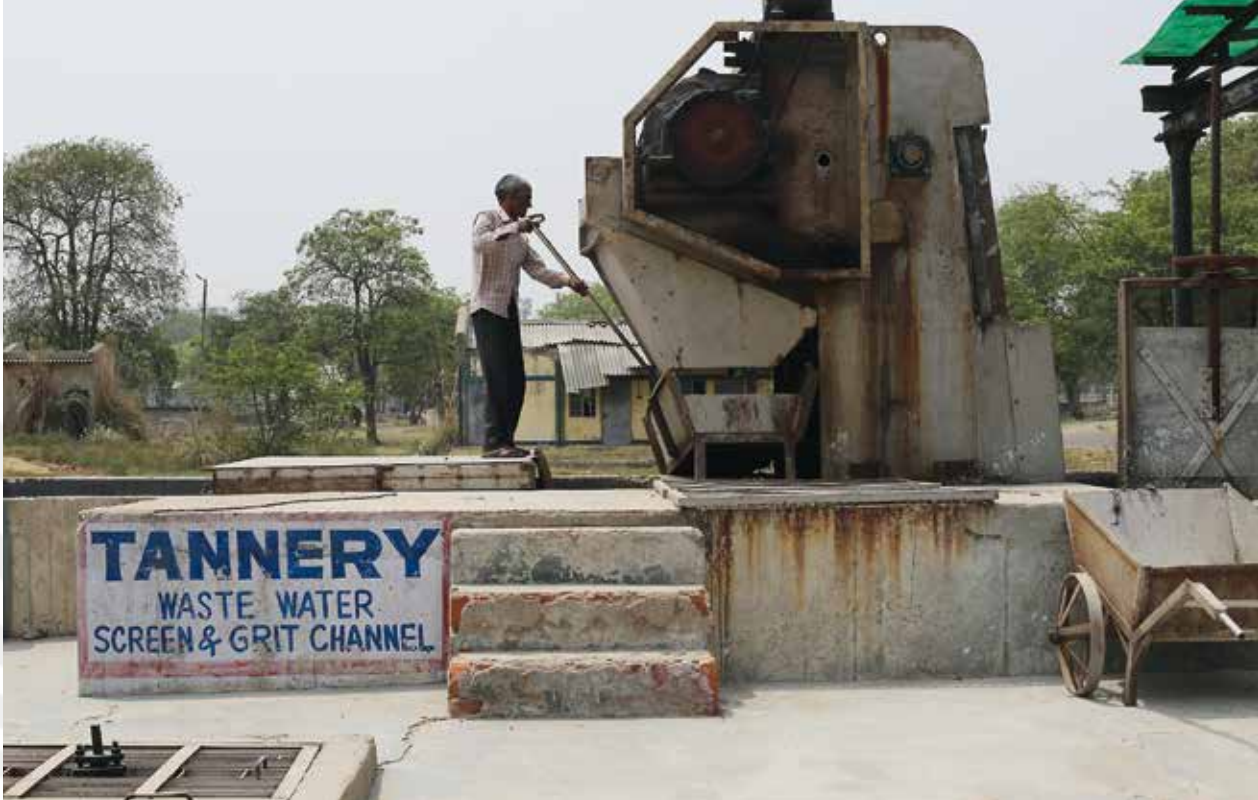
Common Effluent Treatment Plant (CETP) in Kanpur treating tannery wastewater

The wastewater of the Kanpur tanning area Jajmau is conveyed to open drains connected to the pumping stations. However, due to the increase in the number of tanneries, those drains are now overflowing into storm water drains, allowing wastewater to reach the Ganges river without any treatment. The pumping stations which were designed for 9 million litres per day capacity are not able to cope with the increased flow of effluents and this leads to the failure of the entire collection network.

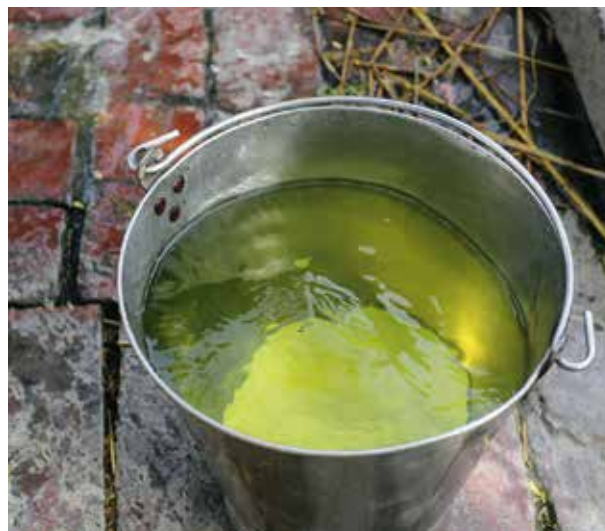
Yellowish water from bore well near COPR dumpsite, highly contaminated with hexavalent chromium

For this study concerning groundwater, in all but one sample total chromium concentrations were within the international and Indian drinking water limit of 50 µg/l.⁴⁷ But extremely high levels of chromium were observed in the groundwater of Khan Chandpur village (13,000 µg/l) of Kanpur Dehat district near a COPR dumpsite. The water itself was greenish yellow in colour and this water should not even be used for washing or bathing (see BOX 2).

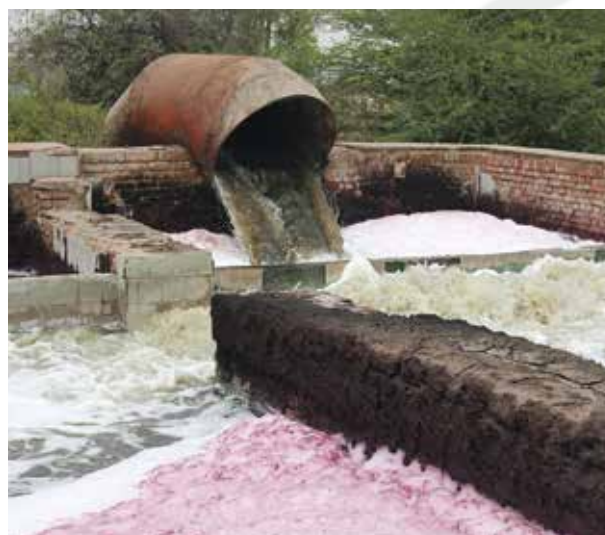
Water from CETP in Kanpur after treatment being used for irrigating the surrounding fields

In Kanpur, treated tannery wastewater is mixed with treated sewage and is used for irrigation on 2,500 hectares of farmland. The same procedure is applied in other tanning clusters, including in Agra. The UN-Food and Agricultural Organisation (FAO) recommends a maximum concentration of total chromium in irrigation water of 100 µg/l.⁴⁸ Water analysis undertaken for this study confirms contamination: our samples showed that water used for irrigation had chromium concentrations over the FAO recommended maximum concentration. Although the water coming from the Common Effluent Treatment Plant (CETP) and reaching the irrigation channel showed no alarming concentrations of Cr(VI) at that specific moment (20 µg/l), in Shekpur, a small village about five kilometres from Jajmau, Cr(VI) in irrigation water from that same channel showed a concentration of 729 µg/l. This is more than seven times the recommended maximum concentration for irrigation water. In the city of Agra, the treated water coming from the water treatment plant and being used for irrigation purposes also showed levels above the recommended limit, with 209 µg/l. In the village of Khan Chandpur mentioned above, the situation was highly alarming as the total chromium exceeded the threshold by more than 100-fold. This water was used mainly for irrigation and as drinking water for animals.

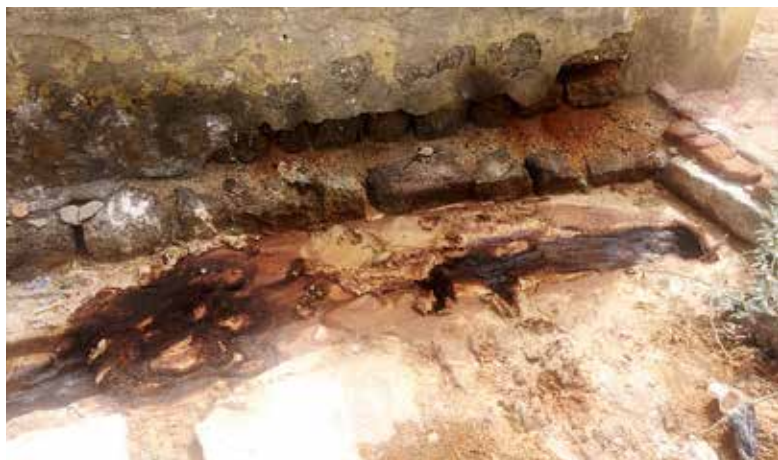
Effluents being taken to ETP through an open drain at a tannery in Peranambut

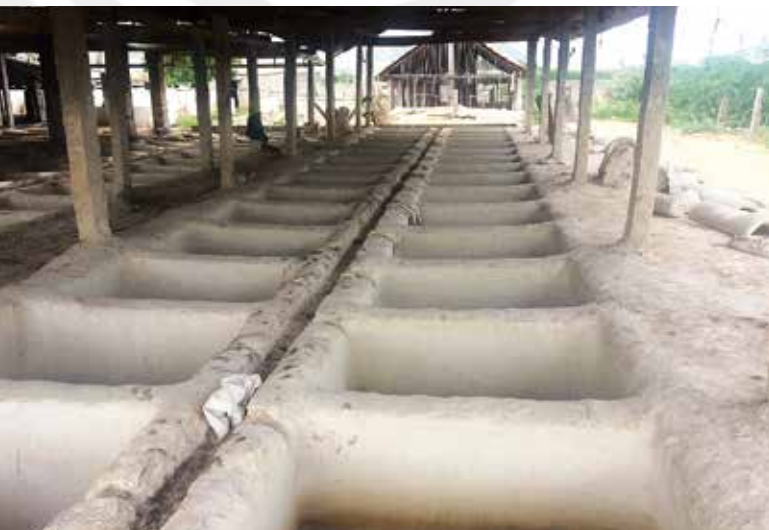
A view of the lime pits in Tannery 1 where the hides are soaked
